Inspection Report

Sample Report

Property Address:
234 Sample Blvd
Home Comming GA 30000

AMG HOME & PROPERTY INSPECTIONS, LLC

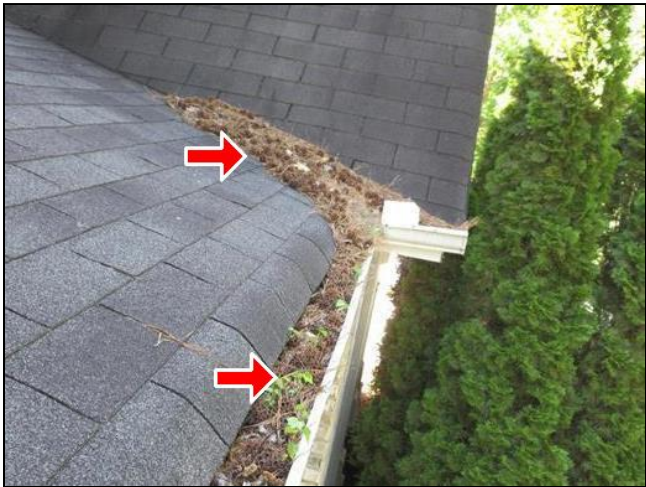
1.3 Item 1(Picture)

- 1.0 The roof covering appears to be in satisfactory condition at the time of inspection.
- 1.3 Gutter and valley at front of home are full of debris. The debris in gutters can also conceal rust, deterioration or leaks that are not visible until cleaned. Recommend cleaning!

Gutter and valley at front of home are full of debris. The debris in gutters can also conceal rust, deterioration or leaks that are not visible until cleaned. Recommend cleaning!

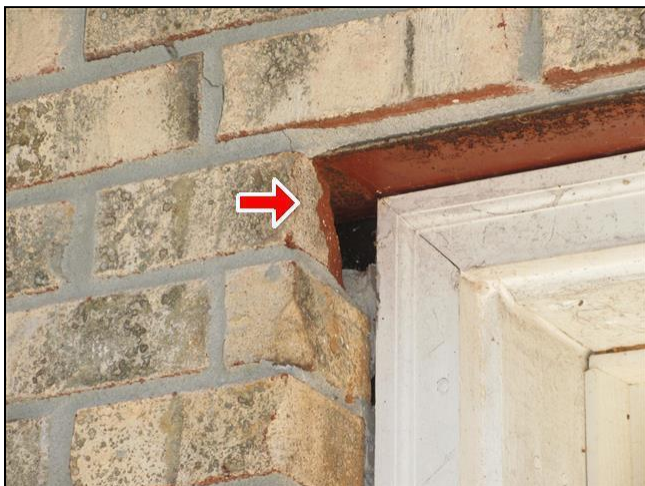
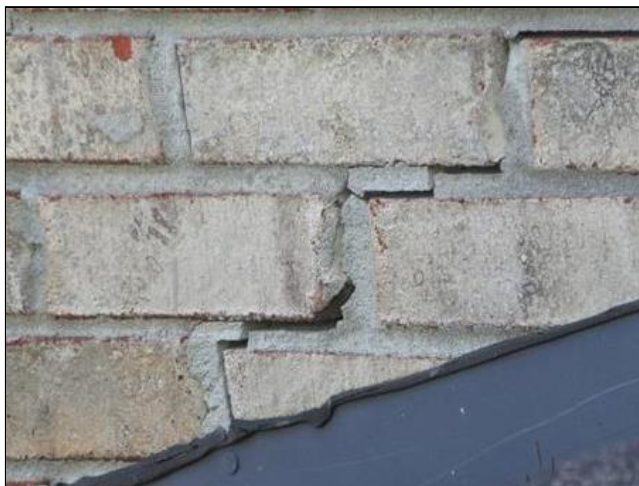
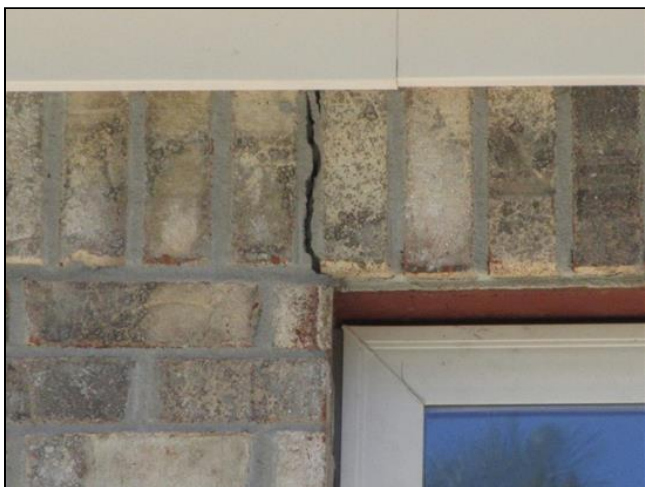
2.0 (1) Damaged brick (top left corner of garage door). Missing mortar at joints below window (left front of home), and above window (right rear of home). Recommend further evaluation and repair by a qualified contractor.

2.0 Item 1(Picture) Damaged brick

2.0 Item 2(Picture) Missing mortar

2.0 Item 3(Picture) Missing mortar

(1) Damaged brick (top left corner of garage door). Missing mortar at joints below window (left front of home), and above window (right rear of home). Recommend further evaluation and repair by a qualified contractor.

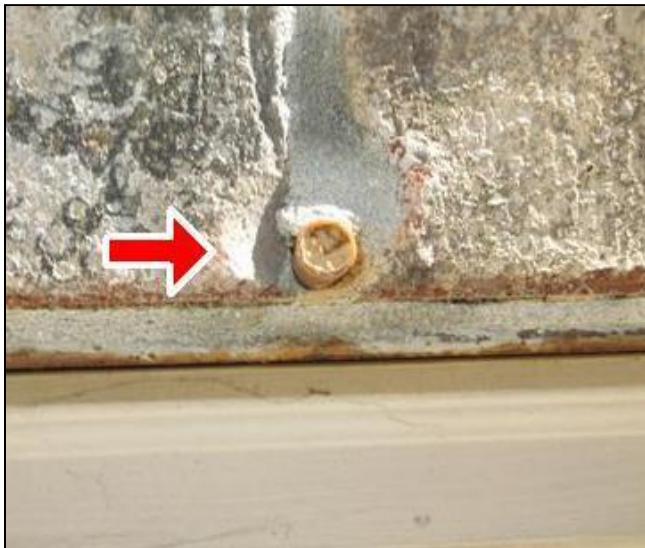
2.0 Item 4(Picture)

(2) Weepholes on brick siding around home are blocked. Weepholes are used to allow water drainage from the brick siding. Recommend repair or replace by a qualified contractor.

(2) Weepholes on brick siding around home are blocked. Weepholes are used to allow water drainage from the brick siding. Recommend repair or replace by a qualified contractor.

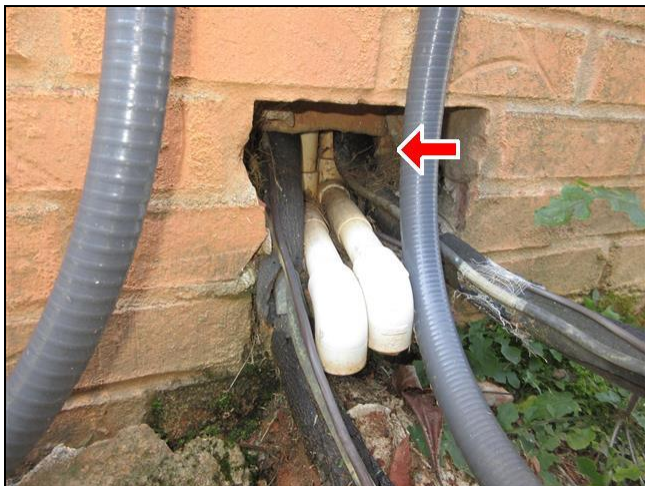
2.0 Item 5(Picture)

(3) All exterior penetrations at the siding (e.g., lights, vents, utilities, etc) should be properly sealed with exterior silicone to prevent moisture and insect intrusion.

(3) All exterior penetrations at the siding (e.g., lights, vents, utilities, etc) should be properly sealed with exterior silicone to prevent moisture and insect intrusion.

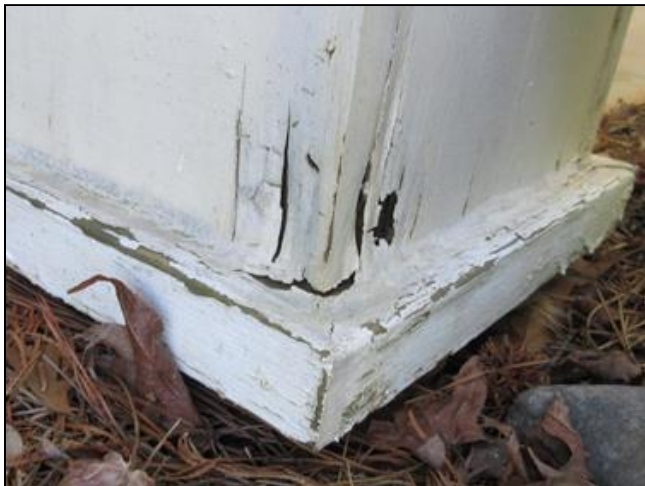
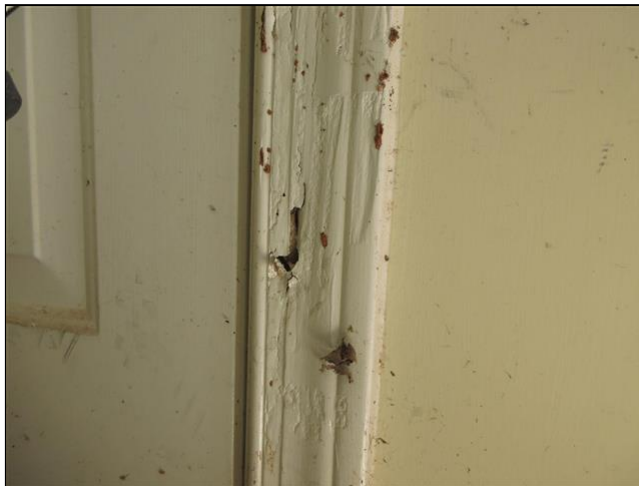
2.3 Termite damage was evident on columns (front porch), and door frame (garage side door). Recommend further evaluation by a qualified termite control company.

Termite damage was evident on columns (front porch), and door frame (garage side door). Recommend further evaluation by a qualified termite control company.

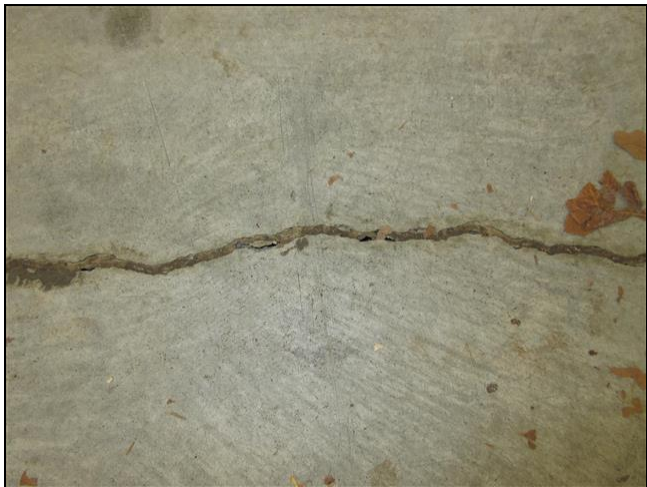
3.2 Item 1(Picture)

3.2 Cracks were evident on garage floor. They appear to have been repaired with some sort of sealant that did not perform well. Recommend further evaluation by a qualified contractor.

Cracks were evident on garage floor. They appear to have been repaired with some sort of sealant that did not perform well. Recommend further evaluation by a qualified contractor.

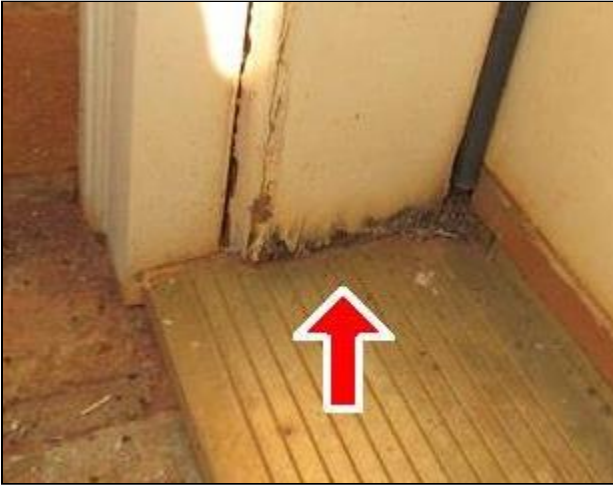
3.3 Item 1(Picture)

3.3 Rotted door jamb (garage side door). Recommend repair by a qualified person.

Rotted door jamb (garage side door). Recommend repair by a qualified person.

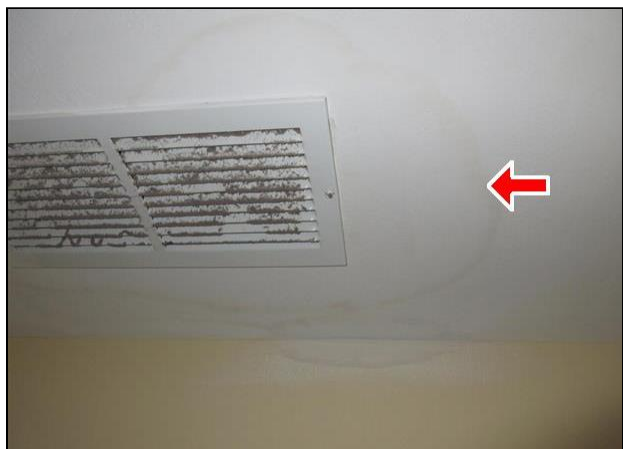
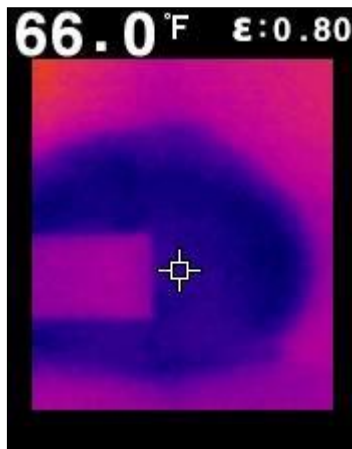
4.0 Blue image indicates that there is presence of moisture on ceiling (bedroom #4). Cause could not be determined. Recommend further evaluation by a qualified contractor. Picture taken with infrared camera.

Blue image indicates that there is presence of moisture on ceiling (bedroom #4). Cause could not be determined. Recommend further evaluation by a qualified contractor. Picture taken with infrared camera.

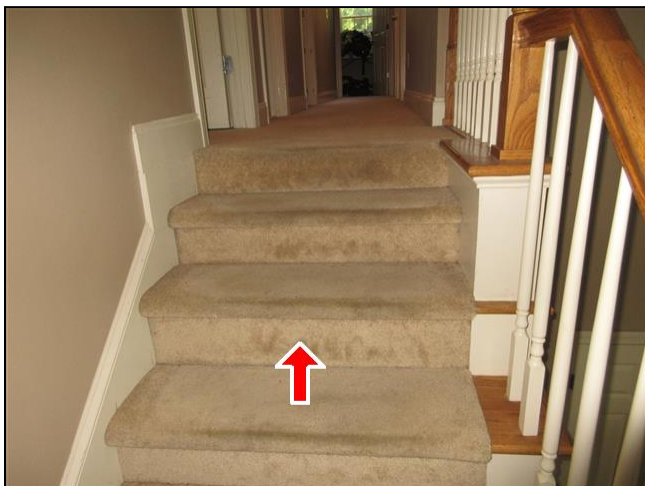
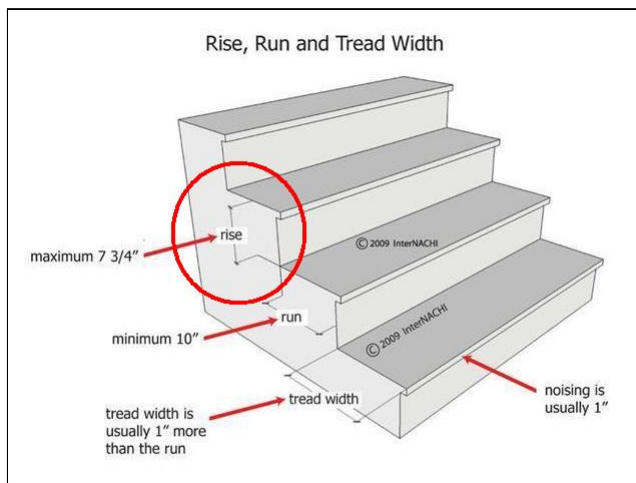
4.3 (1) Maximum Stair Rise should be approximately 7 3/4 inches according to building codes. This riser is 9 inches. This is a safety hazard. Recommend further evaluation by a qualified contractor and corrected.

(1) Maximum Stair Rise should be approximately 7 3/4 inches according to building codes. This riser is 9 inches. This is a safety hazard. Recommend further evaluation by a qualified contractor and corrected.

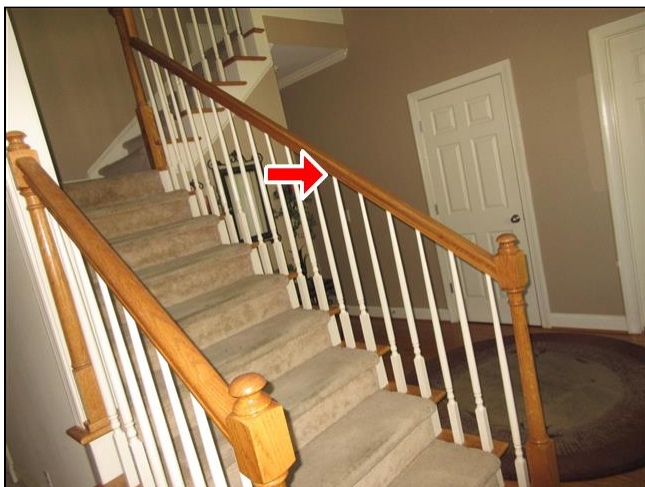
4.3 Item 3(Picture)

(2) Loose railing; have re-secured by a qualified person.

(2) Loose railing; have re-secured by a qualified person.

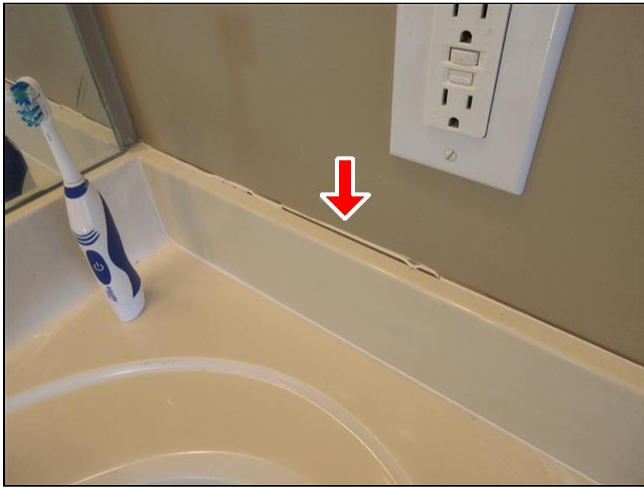
4.4 Item 1(Picture)

4.4 Re-caulking around countertop is recommended (master bathroom).

Re-caulking around countertop is recommended (master bathroom).

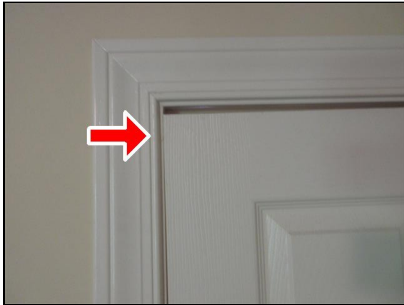
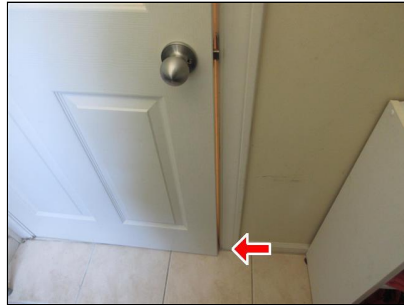
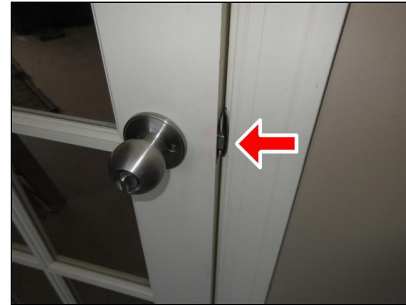
4.5 Doors rubbing at top and bottom (bedroom #4 & laundry room). Also door locks in bedroom #4 and door to master bath are not latching properly. Recommend repair/replace by a qualified person.

4.5 Item 1(Picture) Bedroom #4

4.5 Item 2(Picture) Laundry room

Doors rubbing at top and bottom (bedroom #4 & laundry room). Also door locks in bedroom #4 and door to master bath are not latching properly. Recommend repair/replace by a qualified person.

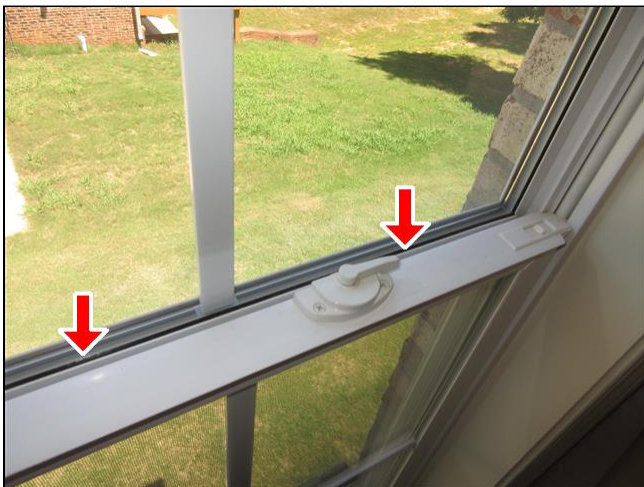
4.6 Item 1(Picture)

4.6 (1) A representative number of windows around home appeared to be jamming at rails when closing. Also window in family room close to rear exterior door difficult to open. Recommend correcting by a qualified person.

(1) A representative number of windows around home appeared to be jamming at rails when closing. Also window in family room close to rear exterior door difficult to open. Recommend correcting by a qualified person.

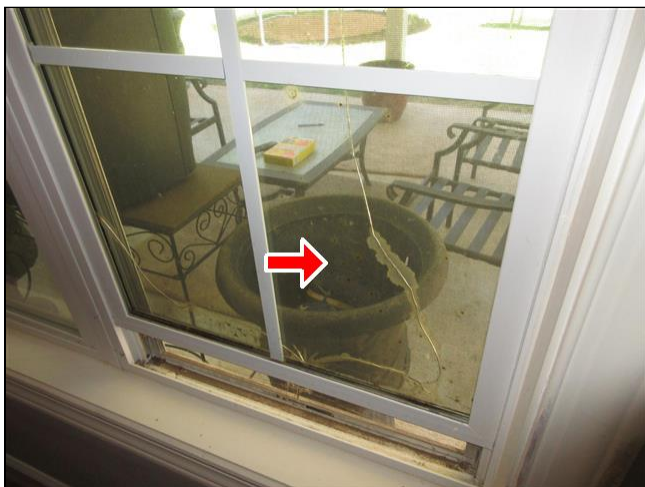
4.6 Item 2(Picture)

(2) Broken window pane (family room); have replaced.

(2) Broken window pane (family room); have replaced.

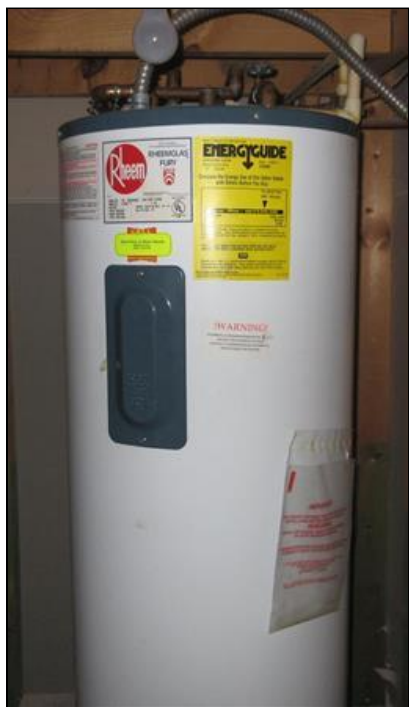
6.0 The Water Heater System was working satisfactory at the time of the inspection. However Water Heaters have a life expectancy of approximately 8 to 12 years. This unit was manufactured in 2003. I would recommend budgeting for a replacement in the near future.

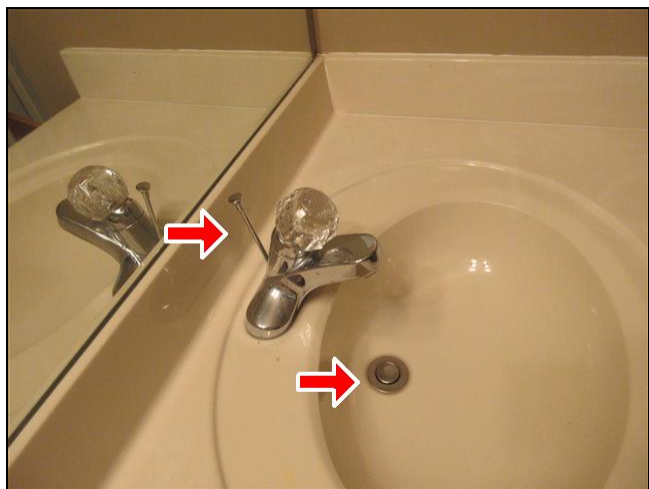
6.2 Item 1(Picture)

6.2 Face sink drain assembly (hallway bathroom & powder room) are not working properly; have repaired or replaced.

Face sink drain assembly (hallway bathroom & powder room) are not working properly; have repaired or replaced.

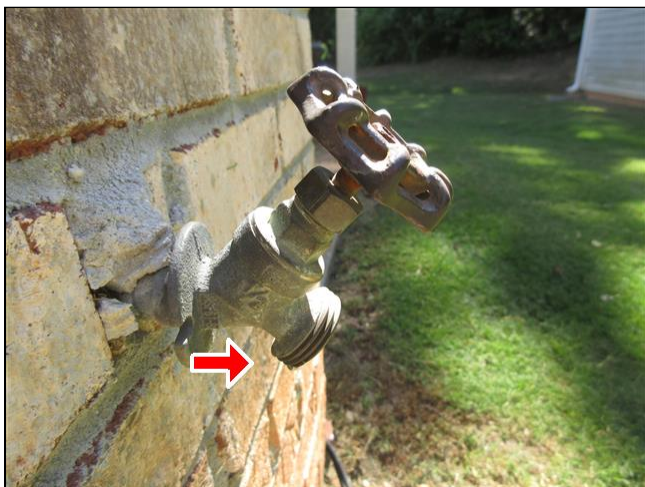
6.3 Item 1(Picture)

6.3 (1) Anti-siphon valve is missing from hose bibs/spigots around the home. Have installed.

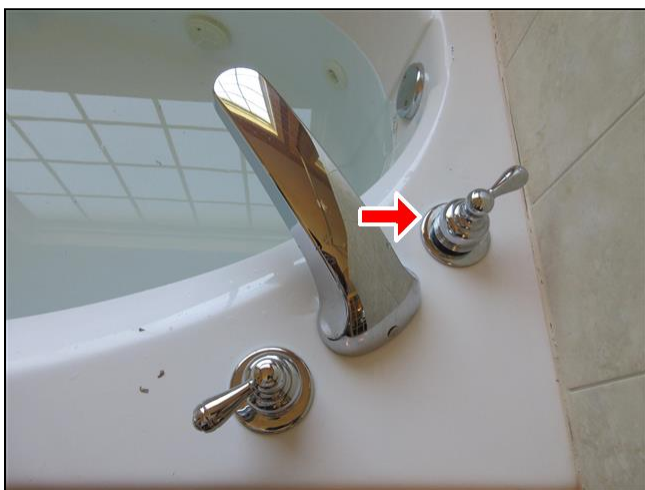
6.3 Item 2(Picture)

(2) Loose faucet handle (Jacuzzi master bath). Recommend re-securing by a qualified person.

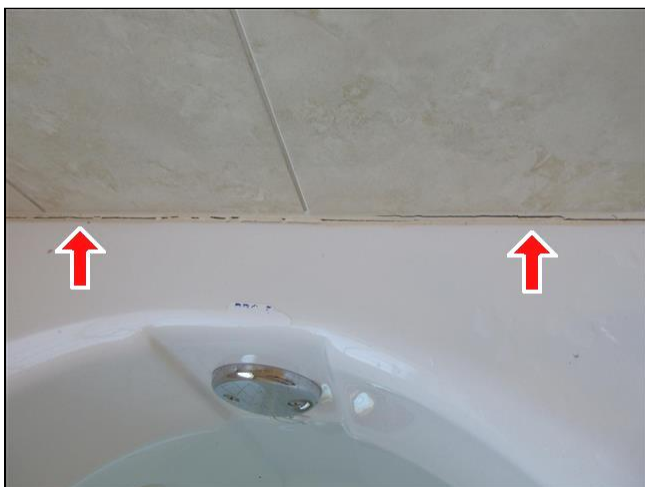
6.3 Item 3(Picture)

(3) Caulking around master bathtub & shower stall, will help prevent moisture intrusion.

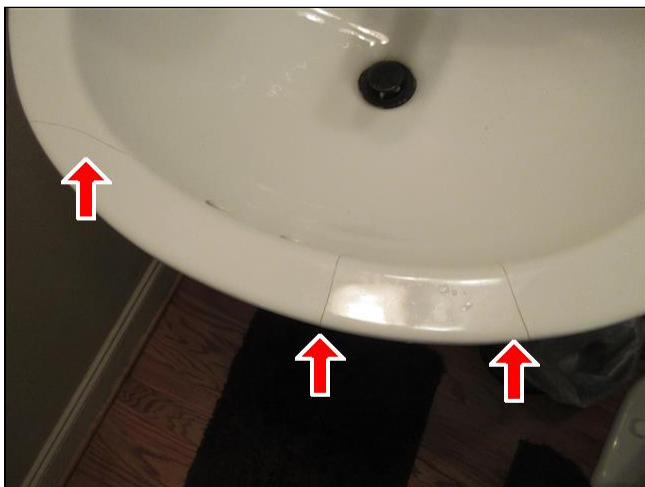
6.3 Item 4(Picture)

(4) Cracked/damaged face sink (powder room). Recommend replacing.

- (1) Anti-siphon valve is missing from hose bibs/spigots around the home. Have installed.
- (2) Loose faucet handle (Jacuzzi master bath). Recommend re-securing by a qualified person.
- (3) Caulking around master bathtub & shower stall, will help prevent moisture intrusion.
- (4) Cracked/damaged face sink (powder room). Recommend replacing.

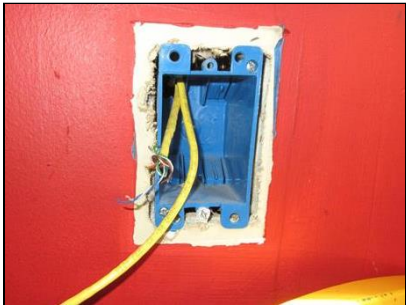
7.3 Item 1(Picture)

7.3 (1) Missing cover plate and exposed wiring (bedroom #2). All electrical wiring should be properly covered and tucked away in junction boxes. Have corrected by a qualified electrician.

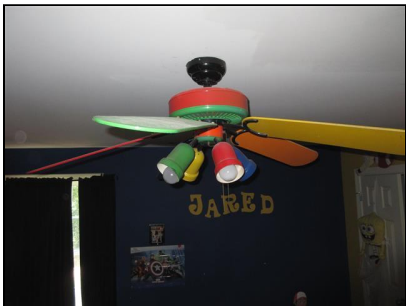
7.3 Item 2(Picture)

(2) Noisy ceiling fan (bedroom #2). Recommend repair or replace by a qualified professional.

- (1) Missing cover plate and exposed wiring (bedroom #2). All electrical wiring should be properly covered and tucked away in junction boxes. Have corrected by a qualified electrician.
- (2) Noisy ceiling fan (bedroom #2). Recommend repair or replace by a qualified professional.

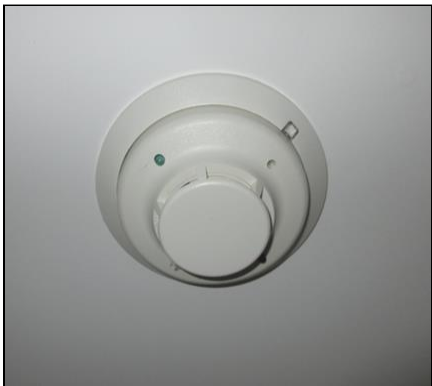
7.7 Item 1(Picture)

7.7 Inoperable smoke detectors around home. Without a working smoke detector in your home you have no first alert to a possible fire. I recommend further evaluation by a qualified person, and repair/replace..

Inoperable smoke detectors around home. Without a working smoke detector in your home you have no first alert to a possible fire. I recommend further evaluation by a qualified person, and repair/replace..

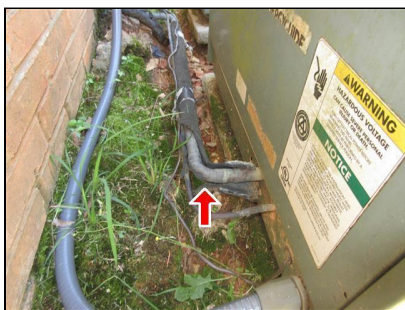
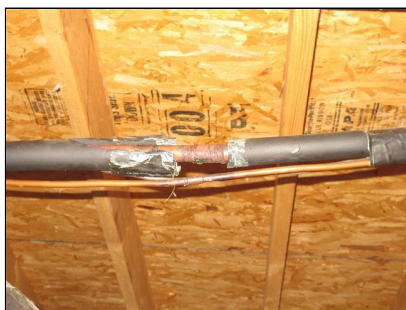
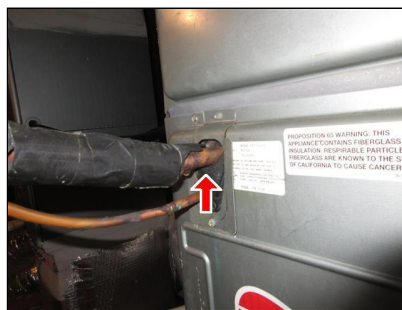
8.1 (1) The refrigerant line on the exterior Heat Pump units and Air Handler unit in the attic, had damaged or missing foam insulation. This may result in reduced efficiency and increased energy costs. A qualified person should replace insulation as needed.

- (1) The refrigerant line on the exterior Heat Pump units and Air Handler unit in the attic, had damaged or missing foam insulation. This may result in reduced efficiency and increased energy costs. A qualified person should replace insulation as needed.
- (2) Wrong size filter. Have replaced with 16x20x1.
- (3) HVAC registers are clogged with dust and needs cleaning to allow cleaner air to circulate home; have corrected. Also I recommend replacing HVAC filters upon taking occupancy of your home regardless of the type. Recommend checking filters monthly in the future and replacing if needed. Frequency of replacing depends on how the system is configured (e.g. always on vs. "Auto"), and on environmental factors (e.g. pets, smoking, frequency of house cleaning, number of occupants, the season).

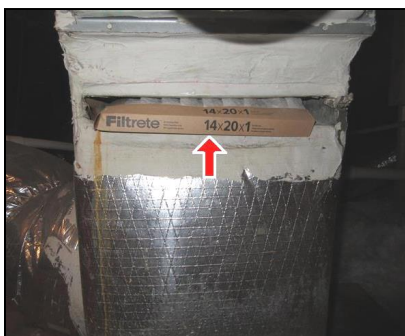
8.1 Item 4(Picture)

(2) Wrong size filter. Have replaced with 16x20x1.

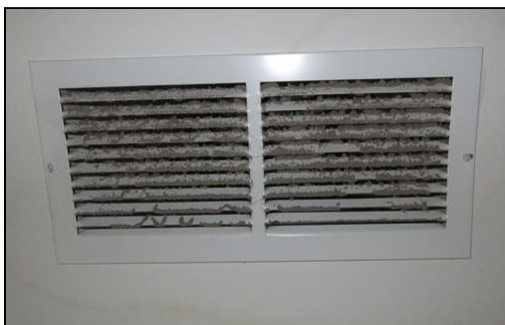
8.1 Item 5(Picture)

(3) HVAC registers are clogged with dust and needs cleaning to allow cleaner air to circulate home; have corrected. Also I recommend replacing HVAC filters upon taking occupancy of your home regardless of the type. Recommend checking filters monthly in the future and replacing if needed. Frequency of replacing depends on how the system is configured (e.g. always on vs. "Auto"), and on environmental factors (e.g. pets, smoking, frequency of house cleaning, number of occupants, the season).

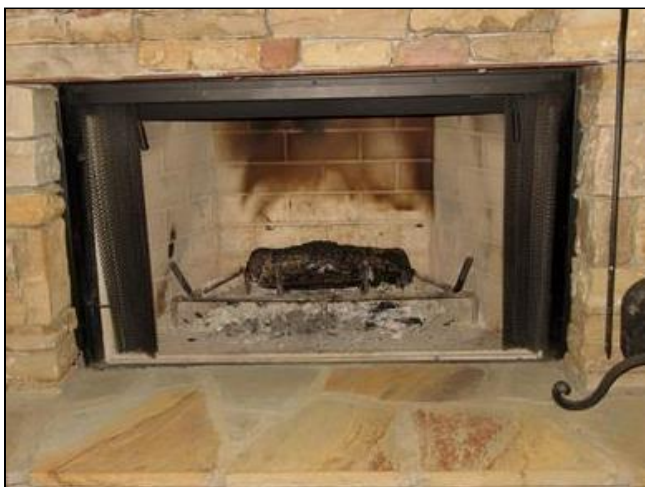
8.4 Item 1(Picture)

8.4 Fireplace is wood burning. Firebox is full of ashes and needs cleaning out. The Chimney Safety Institute of America (CSIA) recommends that a level 2 inspection be completed on the fireplace and chimney upon the sale or transfer of a property. This fireplace should not be used until such an inspection has been done.

Fireplace is wood burning. Firebox is full of ashes and needs cleaning out. The Chimney Safety Institute of America (CSIA) recommends that a level 2 inspection be completed on the fireplace and chimney upon the sale or transfer of a property. This fireplace should not be used until such an inspection has been done.

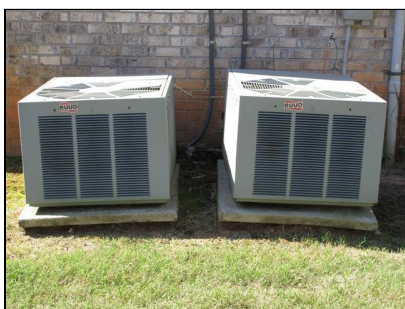
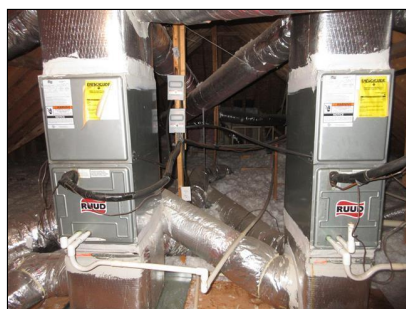
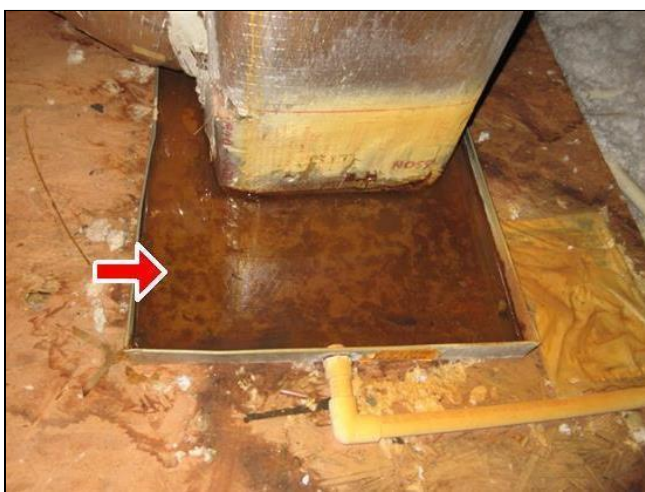
8.5 The Cooling & Air-Handler Systems were operating satisfactory at the time of the inspection. However the secondary drain pans (Air-Handler Units in attic) appear to be clogged and not draining properly; severe evidence of rust was also present. I would recommend further evaluation by a qualified HVAC professional.

8.5 Item 3(Picture) Rusted drain pan

The Cooling & Air-Handler Systems were operating satisfactory at the time of the inspection. However the secondary drain pans (Air-Handler Units in attic) appear to be clogged and not draining properly; severe evidence of rust was also present. I would recommend further evaluation by a qualified HVAC professional.

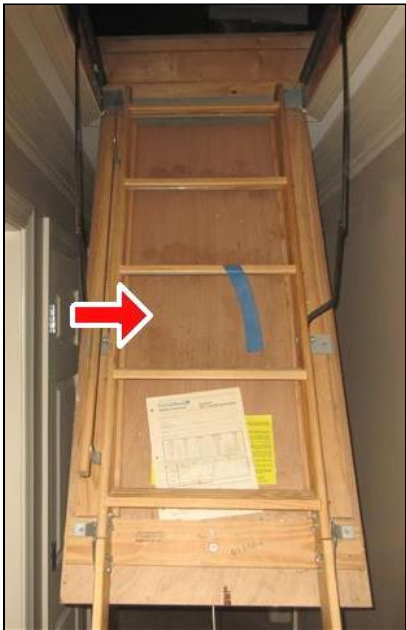
9.0 Item 1(Picture)

9.0 (1) Missing insulation above attic stairs; also no weather stripping around hatch perimeter. To reduce air leakage, I would recommend installing. Interior air leaking into the attic results in heating and cooling losses, increased energy costs, and a possible increase in moisture levels in the attic due to condensation forming on the underside of the roof sheathing during cold weather.

- (1) Missing insulation above attic stairs; also no weather stripping around hatch perimeter. To reduce air leakage, I would recommend installing. Interior air leaking into the attic results in heating and cooling losses, increased energy costs, and a possible increase in moisture levels in the attic due to condensation forming on the underside of the roof sheathing during cold weather.
- (2) Attic insulation is a blown-in fiberglass product of R-30 value or better, which is the minimum recommended for Georgia. The insulation is adequate.

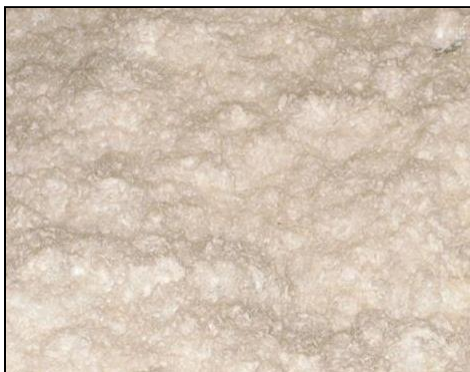
9.0 Item 2(Picture)

(2) Attic insulation is a blown-in fiberglass product of R-30 value or better, which is the minimum recommended for Georgia. The insulation is adequate.

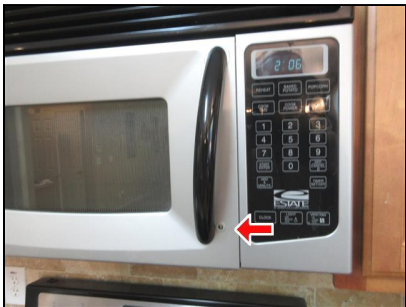
10.4 Item 1(Picture)

10.4 Loose handle; have repaired or replaced.

Loose handle; have repaired or replaced.
